# Manhole Inspection Summary

Manhole # S27A\_\_053MH

Insp Date: **11/6/07 12:04 PM**

**Location** Address: **1101 MYRTLE AVE**

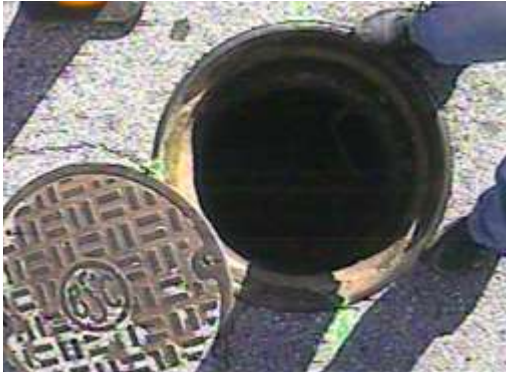
Defect 1

Offset: **2** (in.)

FRAME OFFSET

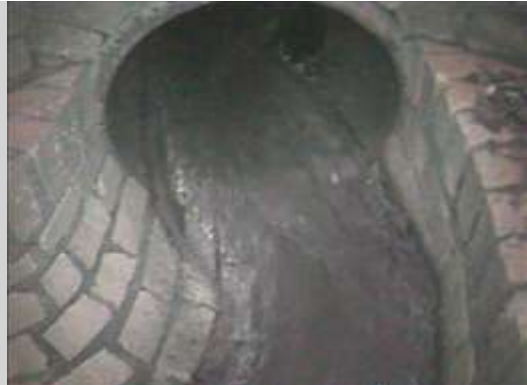
12 O'Clock Outflow

18 in. Circular Gravity Sewer  
Pipe Out @ 12 O'Clock

Pipe Height: **19.2** (in.) Rod and Bar (Angled)  
Pipe Material: **Clay** ☐ Pipe Lined  
Invert Depth: **16.98** (ft.) Flow Characteristics: **Slow**  
Deposits: ☒ None ☐ Mud ☐ Sludge ☐ Debris ☐ Grease  
Silt Depth: (in.) Deposits Extent:  
Infiltration: **None** Pipe Seal Cond: **Sound**

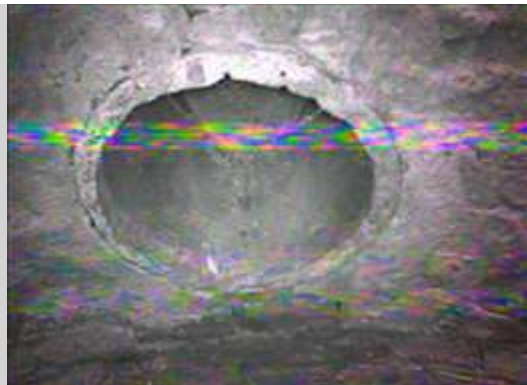
6 O'Clock Inflow

10 in. Circular Gravity Sewer  
Pipe In @ 6 O'Clock

Pipe Height: **9.6** (in.) Rod and Bar (Angled)  
Pipe Material: **Clay** ☐ Pipe Lined  
Invert Depth: **9.22** (ft.) Flow Characteristics: **Slow**  
Deposits: ☒ None ☐ Mud ☐ Sludge ☐ Debris ☐ Grease  
Silt Depth: (in.) Deposits Extent:  
Infiltration: **None** Pipe Seal Cond: **Sound**

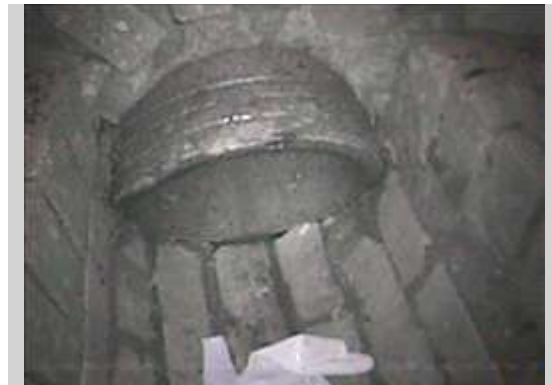
Drop In @ 6 O'Clock

Drop: **Outside Direct**  
Angled: Reading: (ft.)  
Inv Depth: **16.40** (ft.)

Drop Condition: **Open**

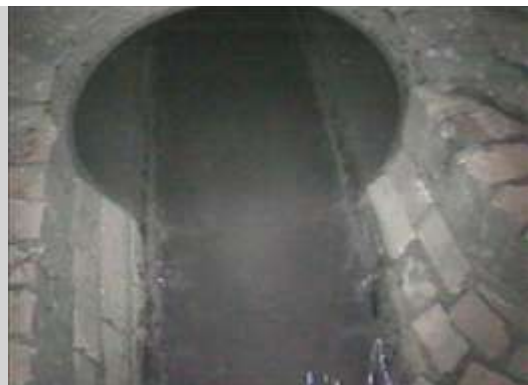
9 O'Clock Inflow

18 in. Circular Gravity Sewer  
Pipe In @ 9 O'Clock

Infiltration: **None** Pipe Seal Cond: **Sound**
